# RL10A-3-3 ROCKET ENGINE OXIDIZER PUMP DEVELOPMENT PROGRAM

Prepared Under NASA  
Contract NAS8-15494  
August 1965 to June 1966

**Pratt & Whitney Aircraft**  
FLORIDA RESEARCH AND DEVELOPMENT CENTER

30 DEC 1966

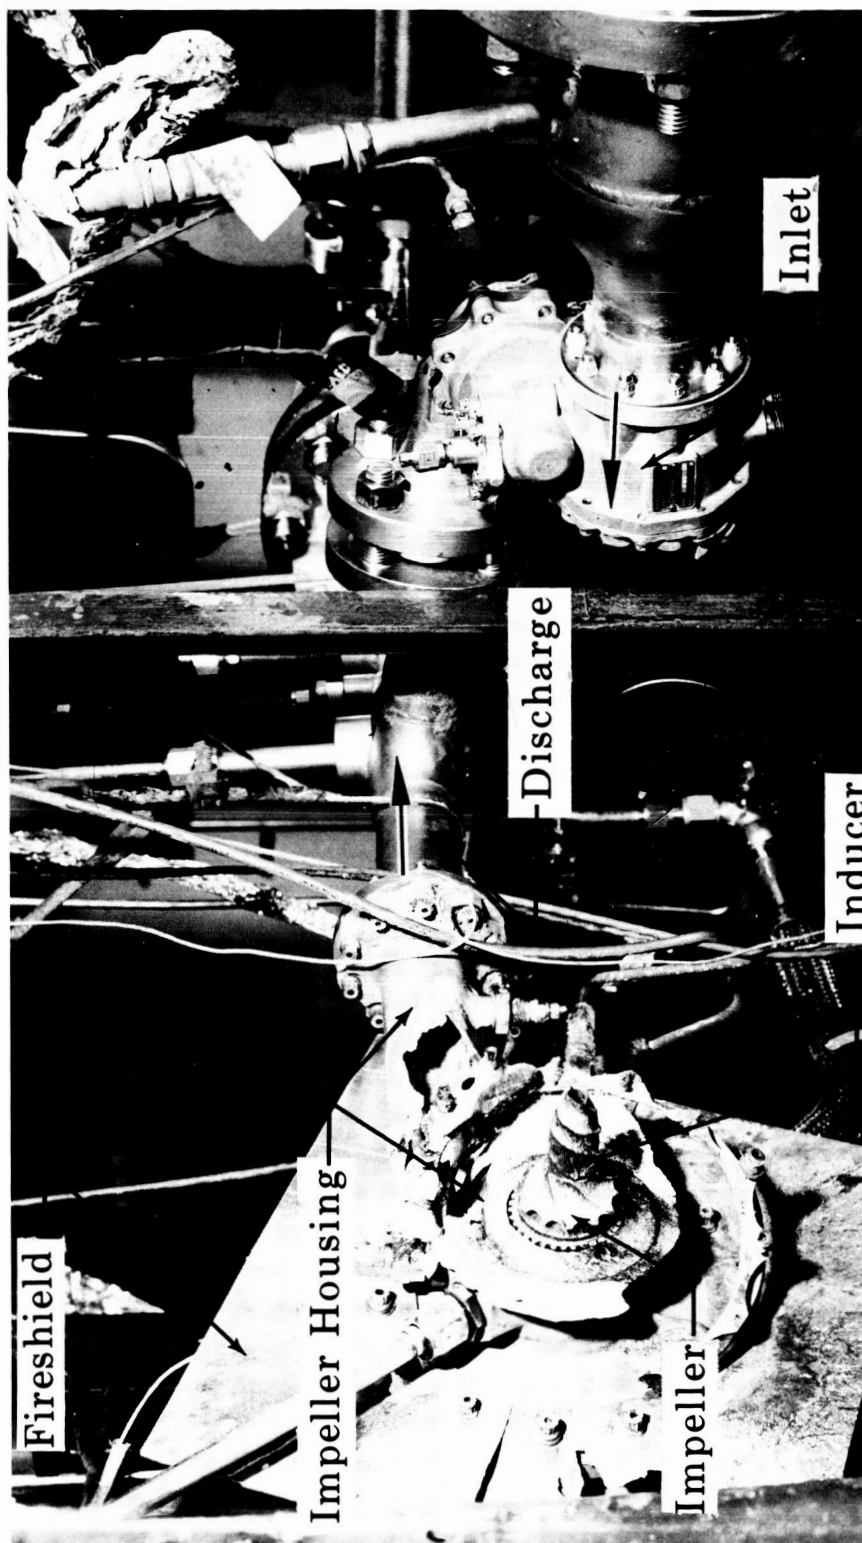
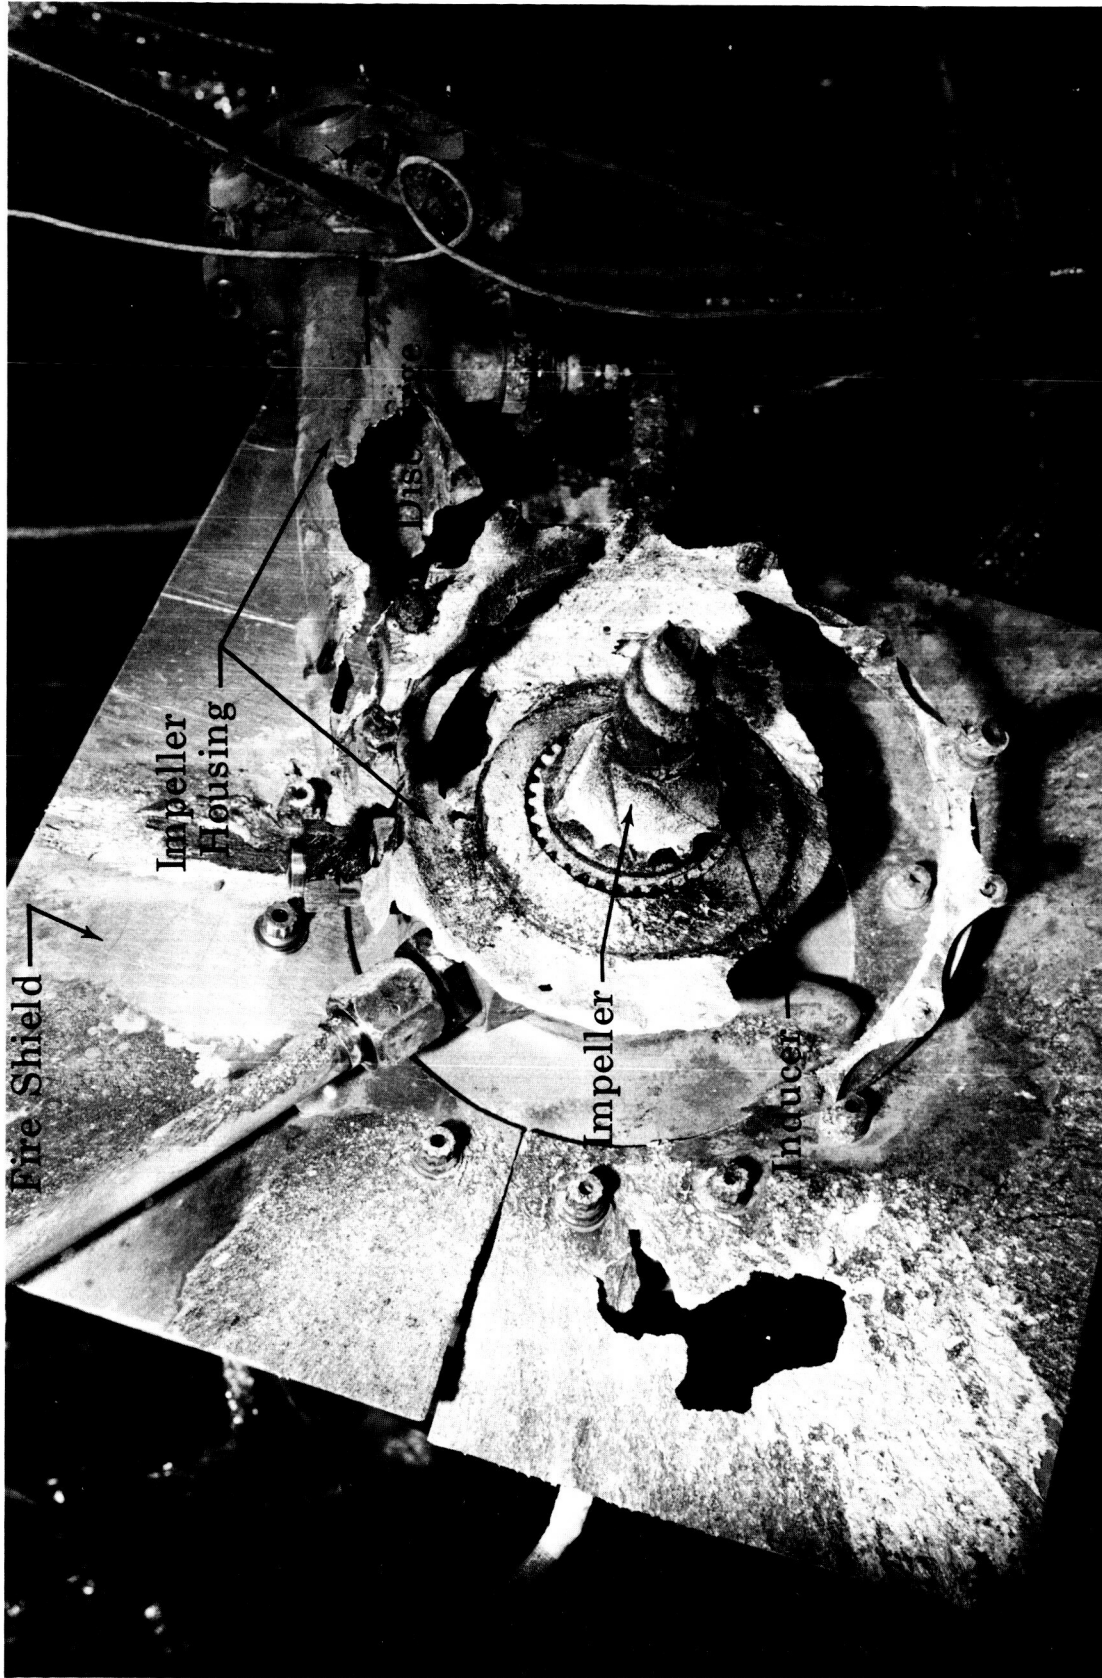
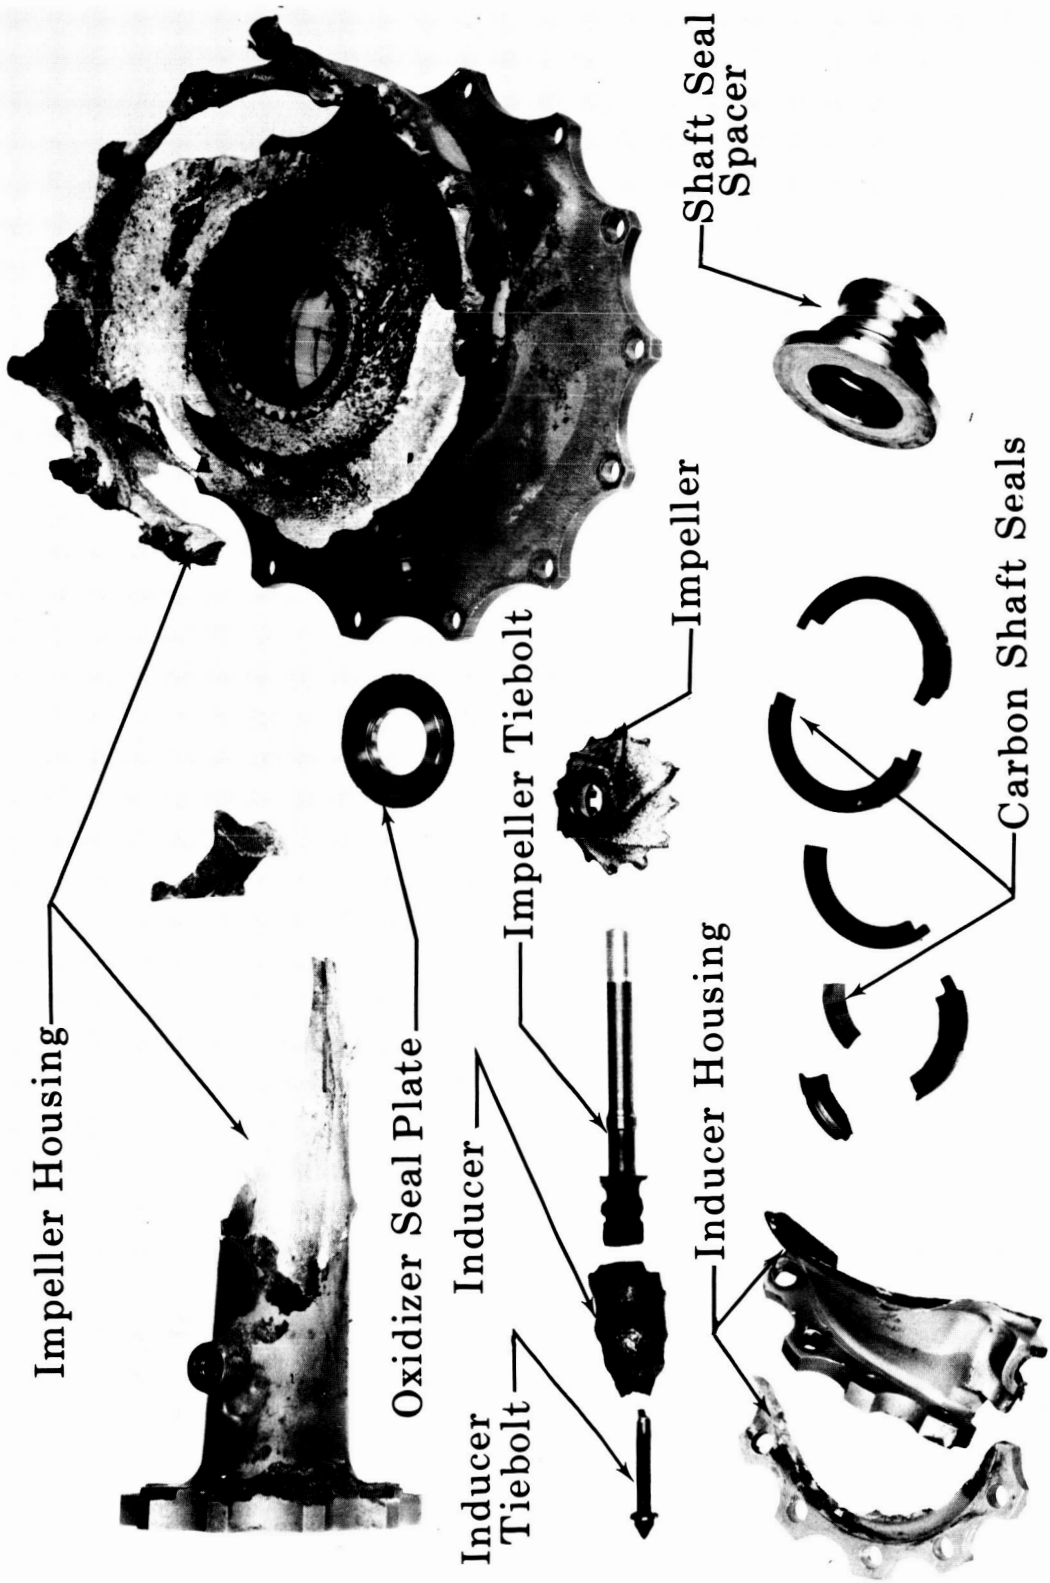
Figure II-24. RL10A-3-3 Oxidizer Pump Failure (Rig B71C003-21)

Figure II-25. RL10A-3-3 Oxidizer Pump Failure (Rig B71C003-21)

Figure II-26. RL10A-3-3 Oxidizer Pump Parts After Failure (Rig B71C003-21)

1. The oxidizer pump fires resulted from a rub between the impeller and the housing
2. The rub was caused by a combination of:
  - a. Side and vibrational loads on the rotating assembly and housing that were higher than expected during operation in deep cavitation. These were aggravated by the experimental, increased diameter pump impeller.

- b. Increased inducer labyrinth seal clearance. This allowed greater deflection of the inducer relative to the housing so that impeller rub could occur before the inducer rubbed and restrained the shaft.
- c. Increased inducer labyrinth seal clearance that, because of increased recirculation leakage, caused a decreased pressure on the front side of the impeller, causing the rotor to run in the forward position.
- d. Less than desirable impeller-to-housing minimum design clearances.

The above combination of parts and circumstances would not occur during engine operation. However, for additional margin the parts list impeller-to-housing clearances were increased. With this design, conditions as severe as encountered in the rig testing would not cause an impeller-to-housing rub.

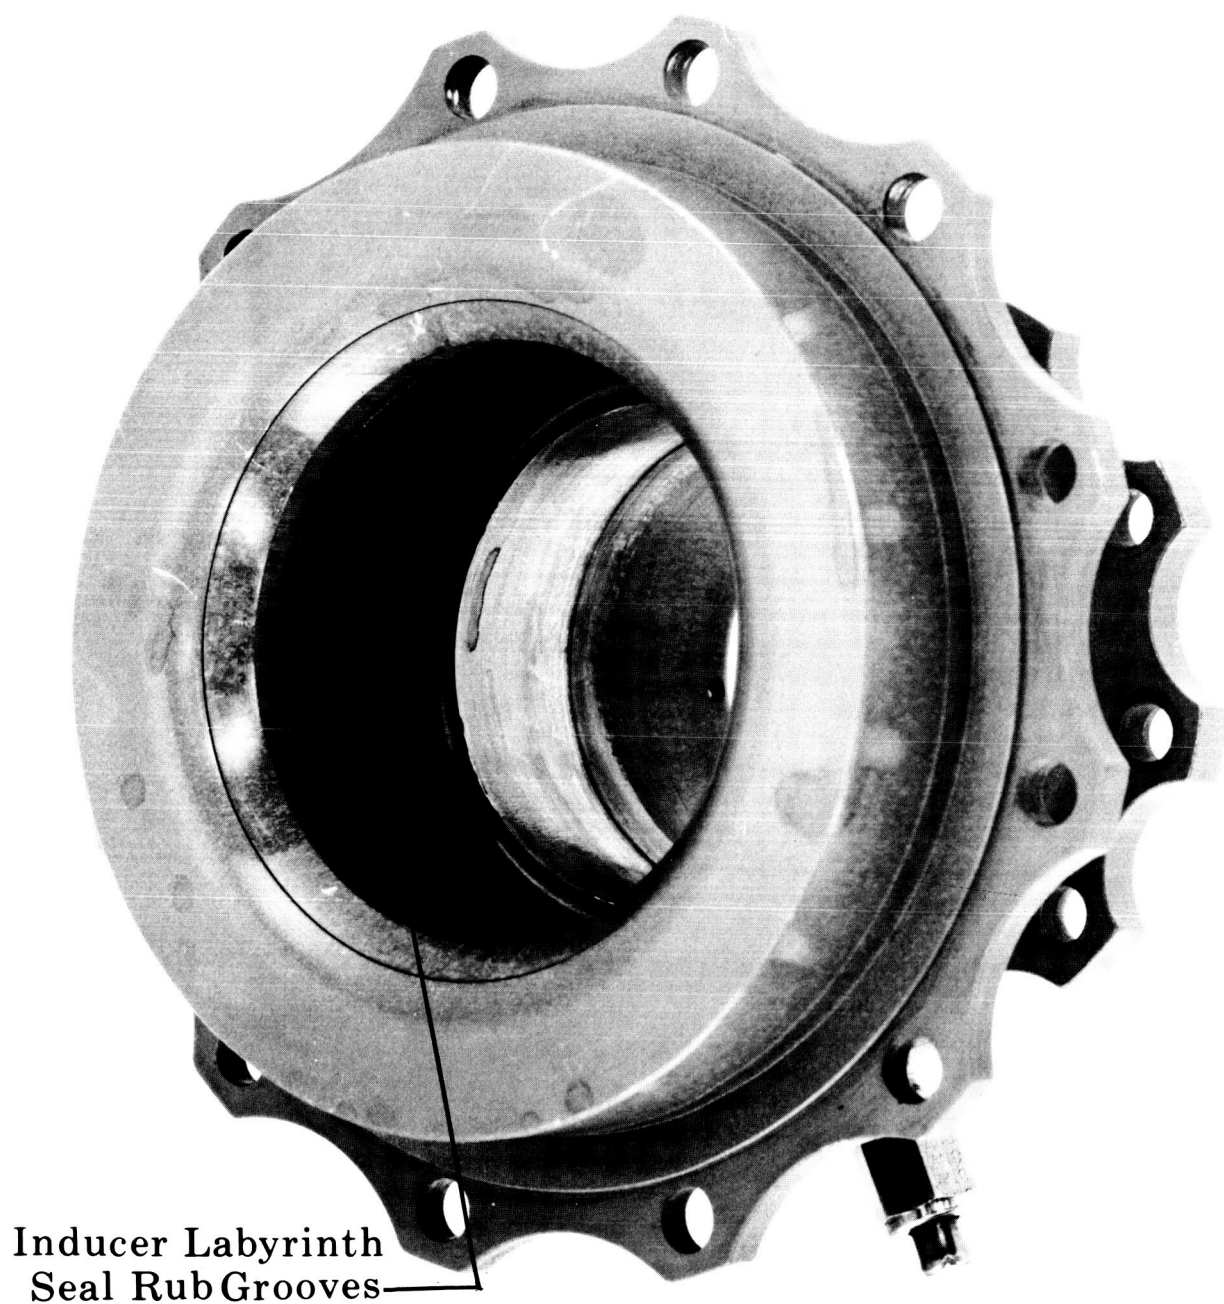
To complete the original program objective, i.e., elimination of metal-to-metal rubbing of the inducer on the housing, testing of an inducer housing was initiated with an abradable carbon insert, similar to the oxidizer pump design in previous RL10 engine models. Carbon was selected because of the extensive satisfactory experience on previous RL10 engine models totaling more than 5500 firings and 800,000 seconds of engine test time. This design required an increased inducer blade-to-housing clearance to prevent any possible blade rub because of the expected increased wear of the carbon material when rubbed by the inducer labyrinth seal as compared to aluminum. The blade diametrical clearance, therefore, was increased in steps from 0.050 to 0.100 in. while the labyrinth seal was set to the parts list diametrical clearance of 0.010 in., reference tests 1 through 4 of rig B71C006, table II-1. The test results, figures II-38 through II-41, show that performance with blade clearances up to 0.100 in. met specification requirements. The labyrinth seals rubbed as expected, but there were no blade rubs as seen in figure II-42.

Inducer Labyrinth  
Seal Rub Grooves

Figure II-42. RL10A-3-3 Oxidizer Pump Inducer  
Housing (Rig B71C006-4)

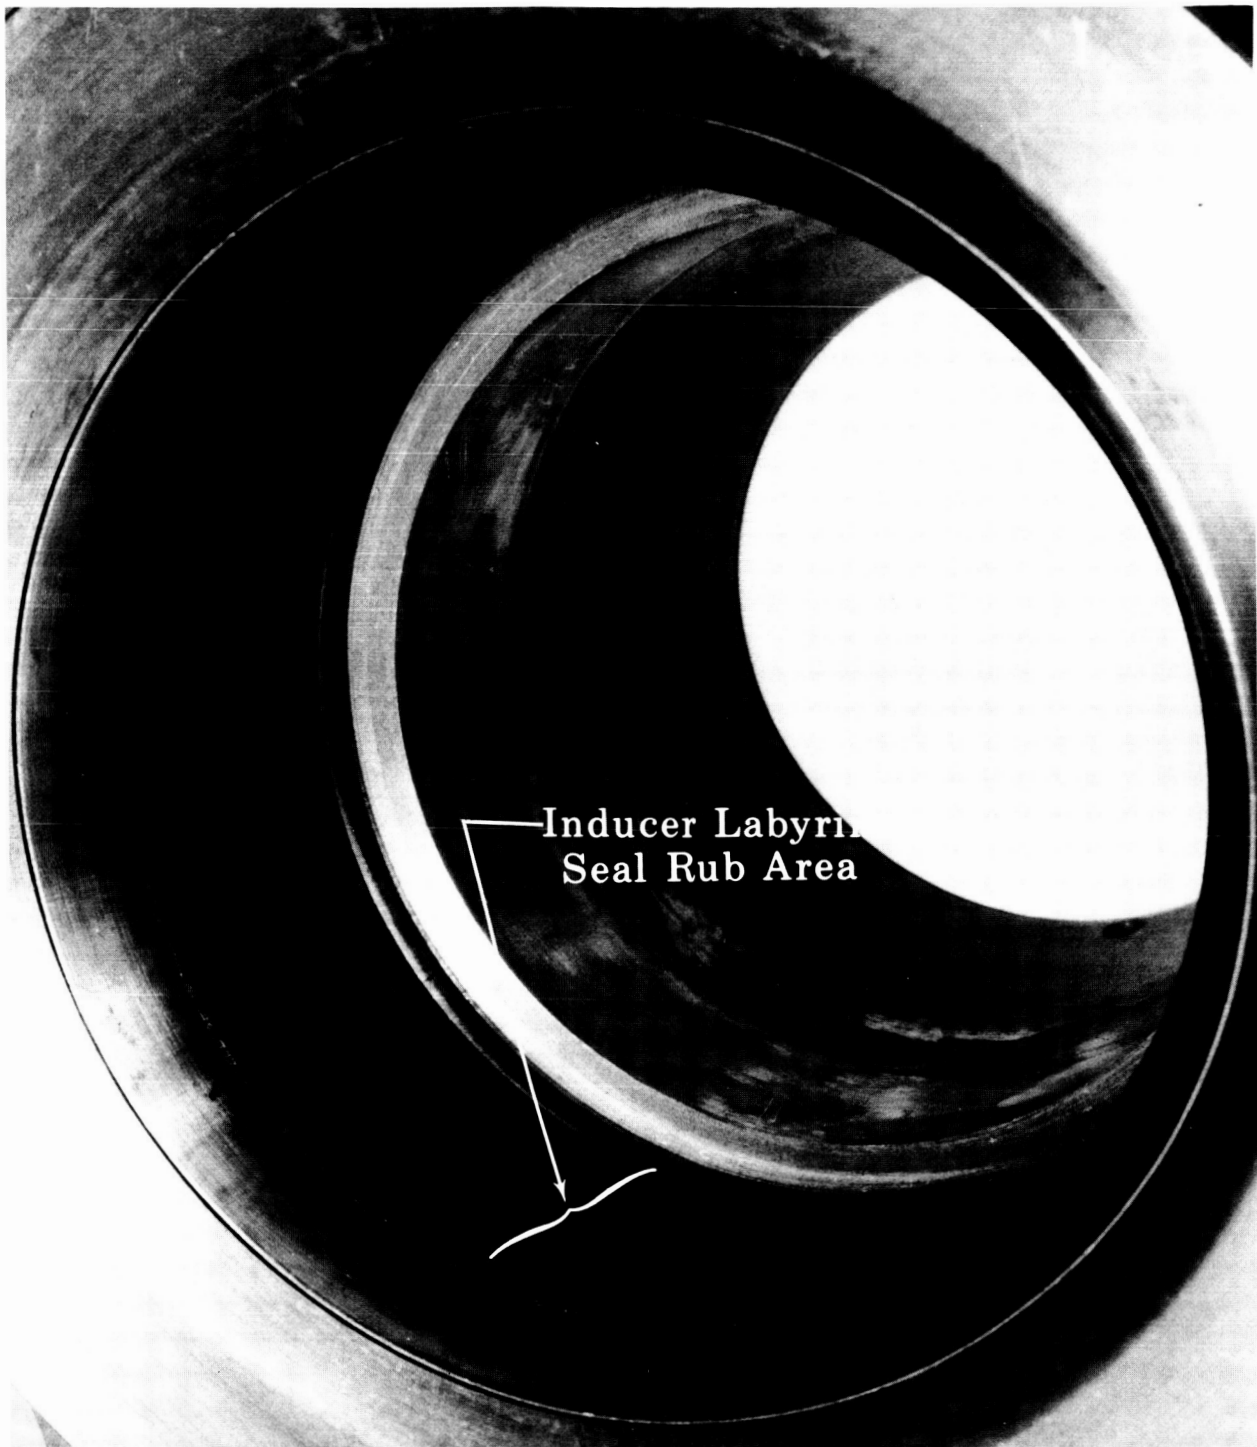
Figure II-45 illustrates the original as compared to the final or current oxidizer pump parts list configuration. The new inducer and inducer housing design was subjected to a 10-hour endurance test on rig B71C006, tests 7 and 8. These tests were conducted with liquid oxygen, one hour at the 10% cavitation level and nine hours with normal engine inlet NPSP levels. Post-test inspection showed the parts to be in excellent condition with no inducer blade rub but with the usual labyrinth seal rubs (figure II-46).

Figure II-46. RL10A-3-3 Oxidizer Pump Inducer  
Housing (Rig B71C006-8)
